Basic Home Energy & Weatherization Audit

Home General Information

Address:
53 Crossacre Street
Starr, SC 29684

Audit Number: 1XXXStanSmith

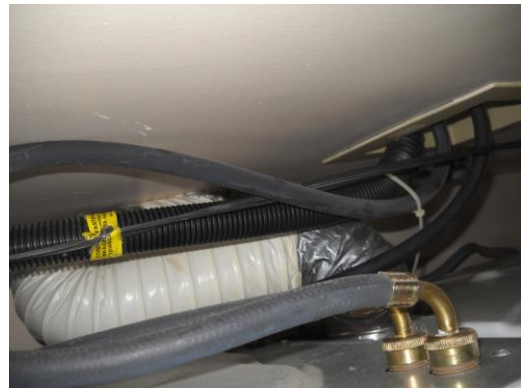
Vent hose is plastic flex.

6. Dryer vent is plastic flex.

Change to metal flex for safety.

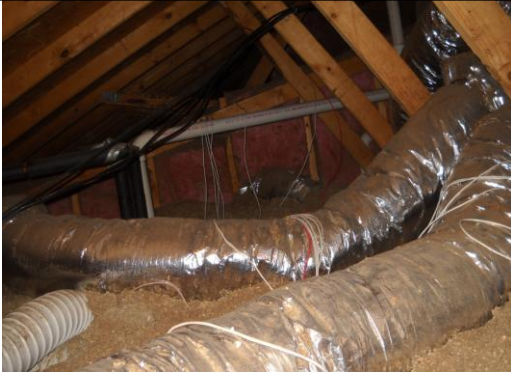
Insulation consists of an average of 7 inches of loose cellulose insulation with an estimated R-value of roughly R-23.

7. Insulation in attic is blown cellulose, average 7 inches.

Bringing the attic insulation level up to R-40 would be cost effective. See SIRs (savings and investment ratios) below.

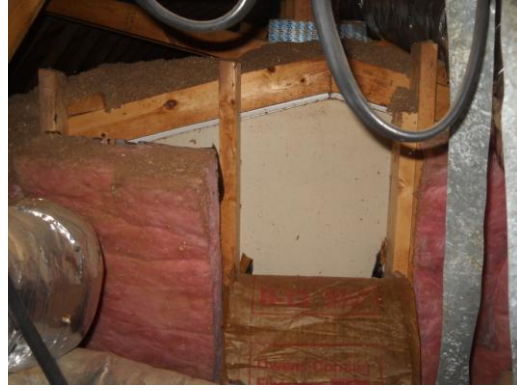
8. Insulation on wall of cathedral ceiling out of position.

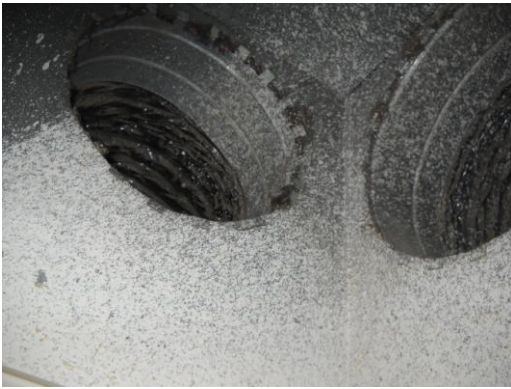
9. Return not sealed.

- 1) Duct system overall in pretty good shape. Recommend sealing the Back Right Bed Closet supply where the boot meets the ceiling. Also, sealing of the return vent will help keep the system cleaner.

- 1) Have units checked and serviced a minimum of once a year.
- 2) Change filters every 3 months at a minimum. Check monthly.
- 3) Seal return to help keep system clean.

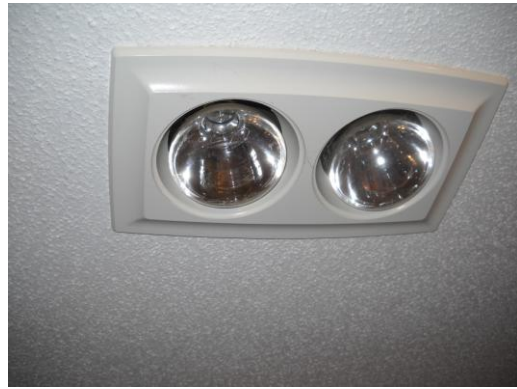
10. Air infiltration from attic at recessed lighting.

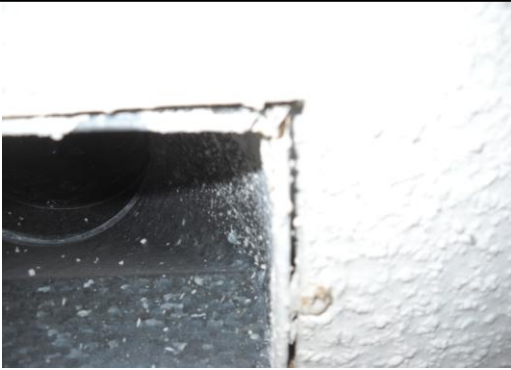
1	Bk Rt Bed	0.4
2	Bk Rt Bed Closet	6.3
3	Frnt Rt Bed	0.8
4	Frnt Rt Closet	0.6
5	Hall Return	1.5
6	Frnt Bath	0.5
7	Frnt Left Bath	0.7
8	Frnt Left Bath Cl	0.8
9	Front Left Bed	0.5
10	Living 1	0.5
11	Living 2	0.5
12	Kitchen	1.1
13	Laundry	0.7
14	Dining	0.5

Pressure pan readings are generated by having the blower door running to depressurize the house. This also depressurizes the duct system, and any cracks or holes in the system cause the air to be sucked into the ducts and into the house. The pressure pan reading is a pressure reading. **General practice is to consider that any reading over 1 warrants the ducts to be checked for leaks and sealed.**

11. This supply had a pressure pan reading of over 6 pascals. All supplies need sealing at the ceiling.
